THE 6th ICRMCE

International Conference on Rehabilitation and Maintenance in Civil Engineering

CONFERENCE PROCEEDING

POLICY, DESIGN, CONSTRUCTION, REHABILITATION, AND MAINTENANCE FOR SUSTAINABLE BUILT ENVIRONMENT

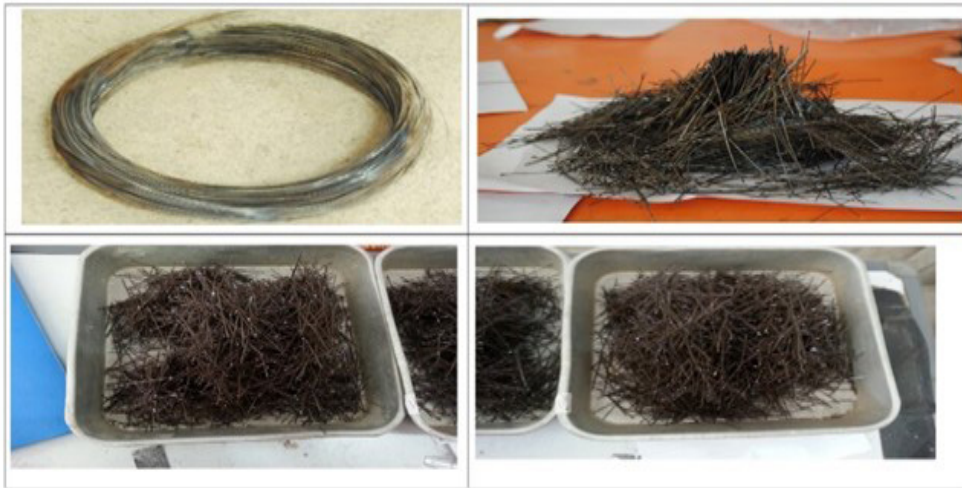
**Fig. 1.** Properties of Rebar Wire Fiber

The investigation of the impact of mixed proportions on the workability of fresh concrete and the hardened properties of SCC involved the creation of self-compacting concrete with different l/d (length to diameter) ratios. Rebar wire fiber of 0.7 mm diameter was considered with the proportion of 0.5% concrete volume. The length of rebar wire fibre were varied from 40 mm, 50 mm, 60 mm, and 70 mm, as shown in **Fig.1**, obtaining the length-diameter ratio of 58,71,86 and 100, respectively.

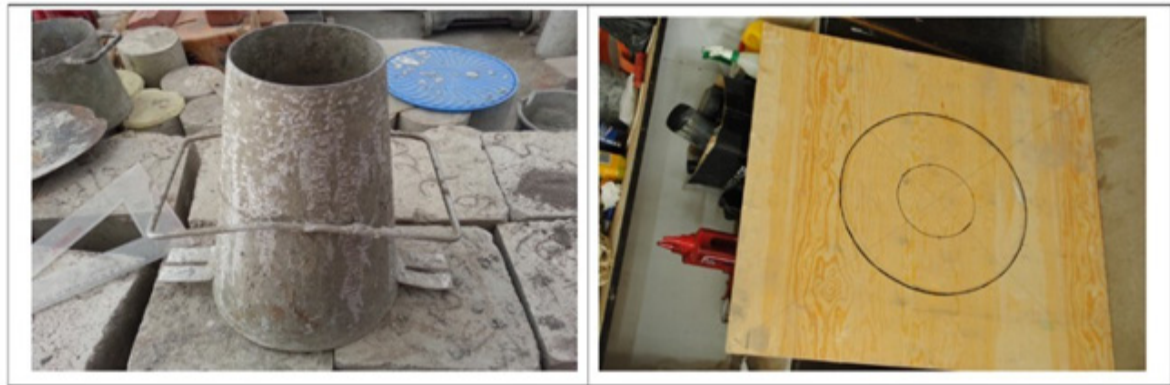
**Fig. 2.** Abarms Cone for Slump Flow Test

The flow ability of SCC and flow rate in the absence of obstacle are evaluated using the slump flow test. Fresh SCC is poured into a cone during the testing procedure, and the cone is then drawn higher. T500 time, as seen in **Fig.2**, is the amount of time that passes between the cone's upward movement and the point at which the concrete flows to a 500 mm diameter.

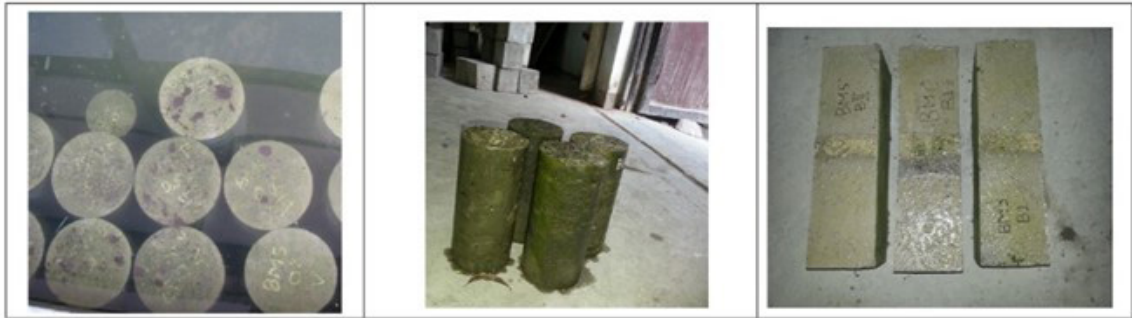
Fig. 3. Curing Concrete Specimen

Concrete's mechanical qualities were assessed using compressive strength in accordance with astm C39. [15] and splitting tensile tests on ASTM C 496-96 [16]. 150 mm in diameter and 300 mm in height cylindrical molds were used to cast the fresh concrete. The concrete was demolded the day after it was cast, and it cured for 28 days in tap water as shown in **Fig 3**.

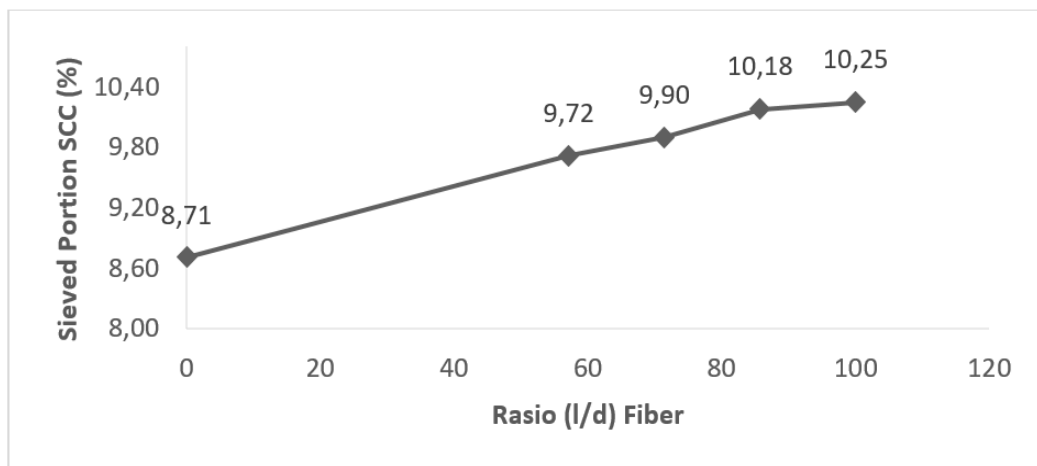
Fig. 7. Flowability Test Result of Self-Compacting Concrete

According to the test result, adding rebar wire fiber to the SCC mixture results in a rise in segregation resistance and a loss in filling and passing capacity. In addition, the strength climbed to 71 with the addition of rebar wire fiber and then steadily decreased after that. When SCC's workability results fall within the per-mitted range specified by the technical specification EFNARCH for SCC at a great filling capacity [14]

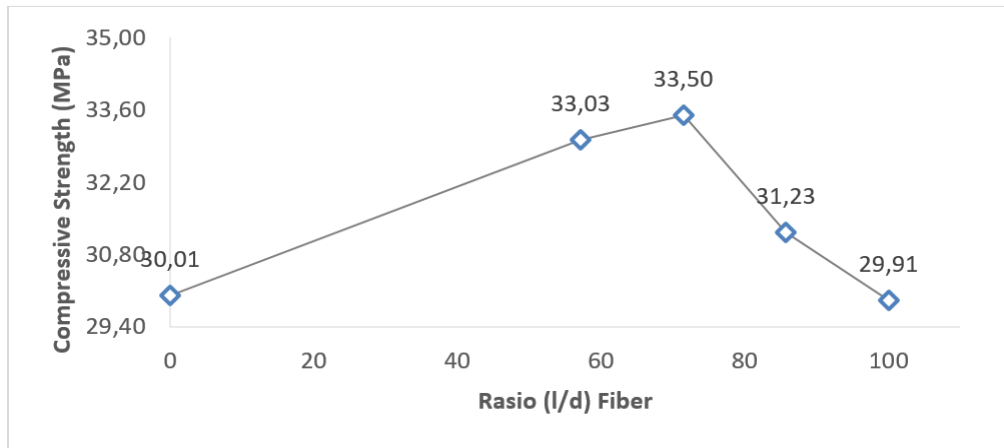
Fig. 8. Compressive Strength Test Result

The hardened SCC compressive strength test results, which ranged from 58 to 100 in l/d ratio, are shown in **Fig.8**. Concrete's compressive strength determines the greatest compressive load it can withstand. According to the result, the average compressive strength increased as the l/d ratio of rebar wire fiber added in SCC raised up to 71 and decrease as displayed in **Fig.8**. The highest compressive strength was acquire at l/d ratio of rebar wire fiber 71. However, beyond l/d ratio 71 the strength was reduced. This demonstrates that there is an optimal limit l/d ratio in fiber rebar wire for usage in SCC mixes.

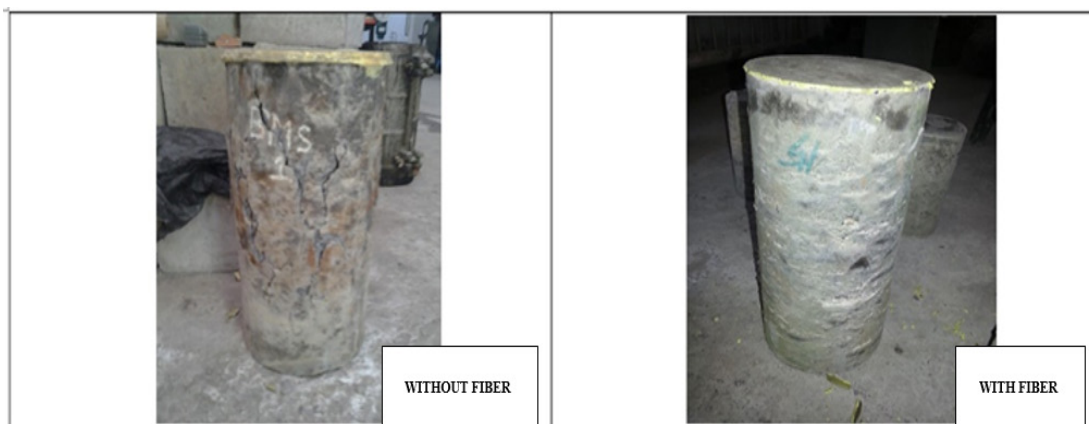
Fig. 9. Crack Pattern after Compressive Strength Test

In Addition, the crack pattern of hardened SCC after compressive strength test show different between SCC with rebar wire fiber and without rebar wire fiber as shown in **Fig 9**. This relate to rebar wire fibers mechanical characteristics and physical makeup, which allow it to withstand the emergence of microcracks and appropriately halt their propagation. [17]. The mechanical properties that could result from the composite's weakening within the cement matrix when more fiber-containing spaces are produced [4]. There was some similarity with the result of steel fiber reinforcement SCC [5], shows that steel fiber refers to the use of post-cracking ductility to control cracking and the mode of failure.

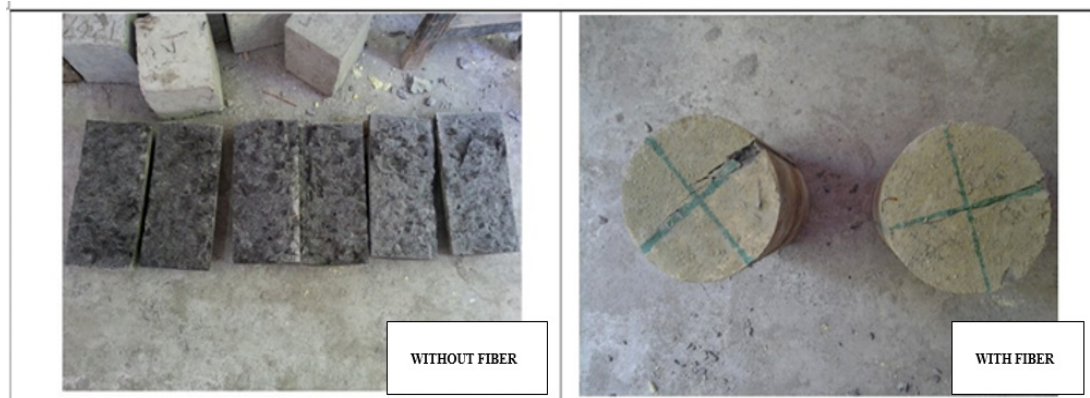
Fig. 10. Crack Pattern after Splitting Tensile Test

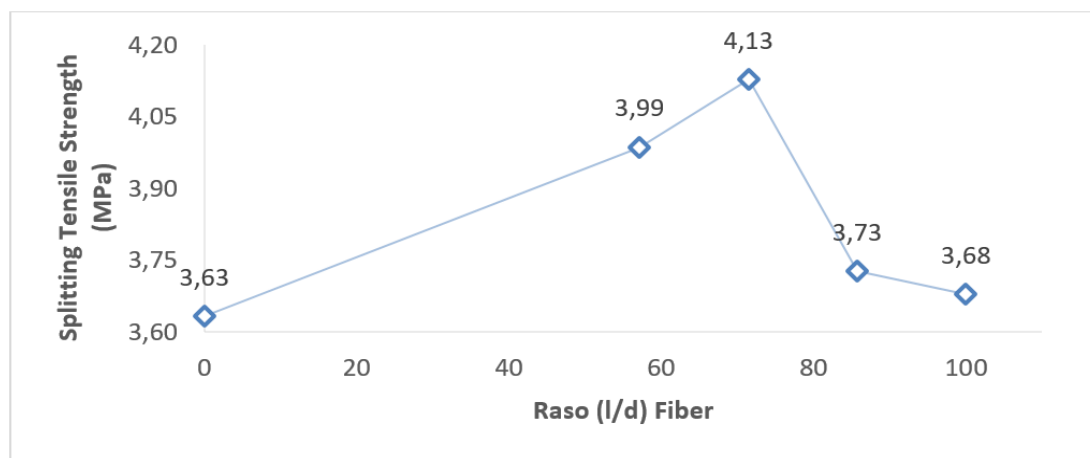
Fig. 11. Splitting Tensile Test Result

The splitting tensile strength was increase as increasing of l/d ratio raise up to 71, as seen in **Fig.11**. The mechanism of SCC stopping crack growth is responsible for the strength improvement brought about by the fiber's presence [4]. When ratio l/d in rebar wire fiber climbed by more than 71, the improvement in SCC was less. The cylinder of SCC without rebar wire fiber was unexpectedly failure into two pieces shown in **Fig.10**. In contrast, the rebar wire fiber cylinder SCC broke ar failure without separating into two halves. The cause of this phenomenon is that the fiber in the con-crete inhibits the growth of internal microcracks, increasing the material's tensile strength.

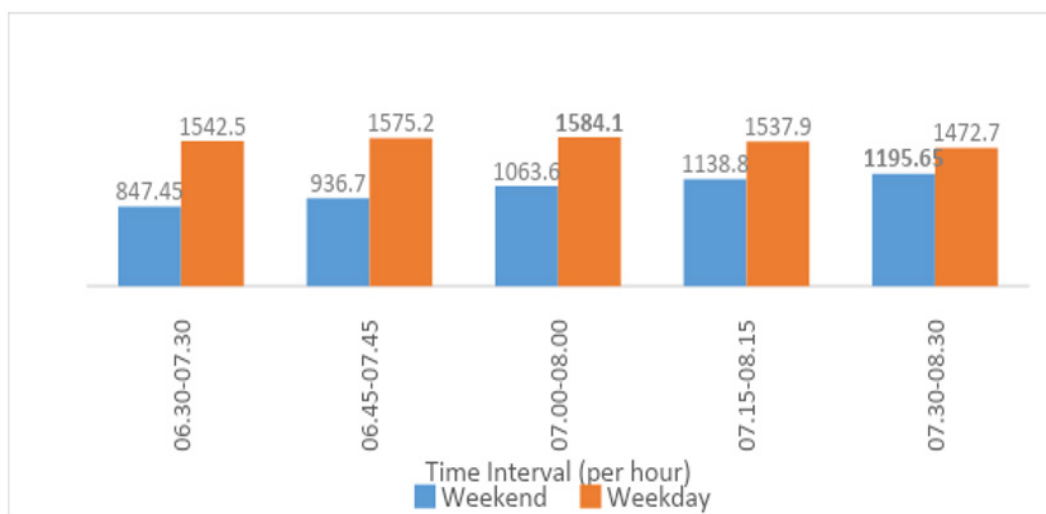
Fig. 1. Traffic volume condition in the morning

The number of vehicles obtained from the survey on weekends and weekdays is divided into two sides, namely the west side and the east side in units of pcu/hour. The results of traffic volumes for two days in the morning and afternoon are shown in Figure 1 and Figure 2.

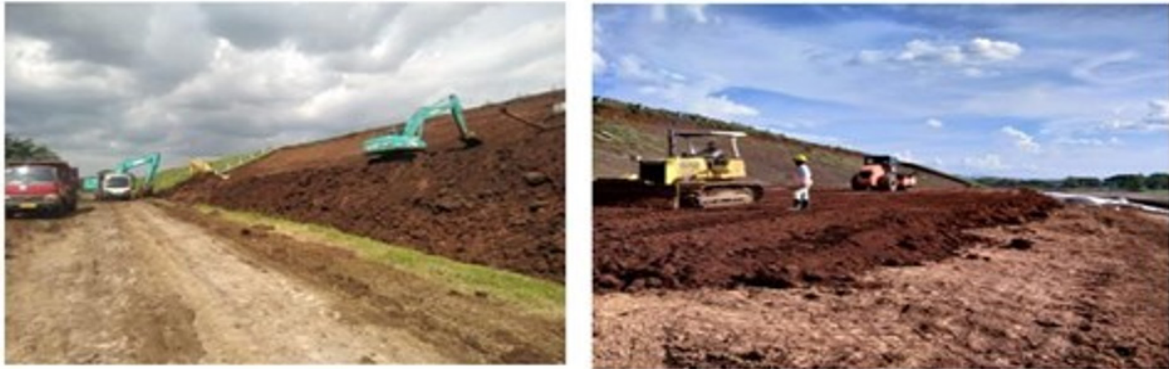
Fig. 7. Excavation of Dam Slope and Embankment of New Material of Lalung Dam Rehabilitation Project.

Based on the review design, Lalung Dam rehabilitation construction work can be done faster because the excavation and embankment material volume is less than planned.

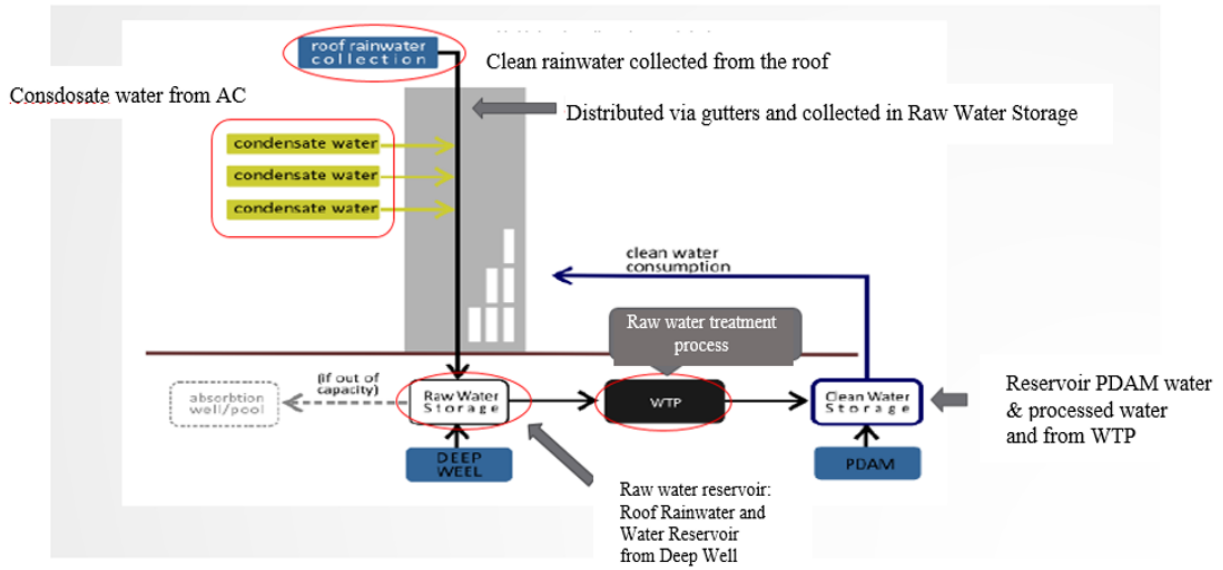
Fig. 2. Water Recycling Concept for the 2nd Campus Polytechnic of Public Works

Water Recycling has 1 benchmark. The benchmark is the use of used water which is recycled for flushing and/or cooling water needs. Based on the results of interviews with the person in charge of the building, Campus 2 Building of the Public Works Polytechnic recycles water used for ablutions. The results of recycling used ablution water are used as flushing. Another benchmark is to provide the installation of a rainwater storage tank with a capacity of 20%, 35% or 50% of the amount of rainwater that falls on the roof of the building. Calculations are carried out using a rainfall intensity value of 50 mm/day. Based on the results of interviews with the person in charge of the building, the Public Works Polytechnic Campus 2 building has a rainwater collection installation with a capacity of 35%.

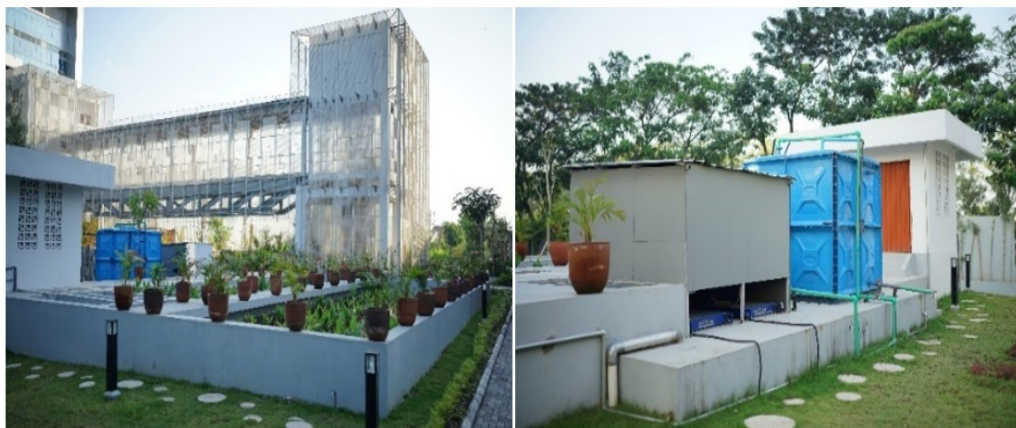
Fig. 4. Waste Water Treatment
